Sample 2023 Condominium Las Vegas

Full Study

Year Beginning: 01/01/2023

Better Reserve Consultants

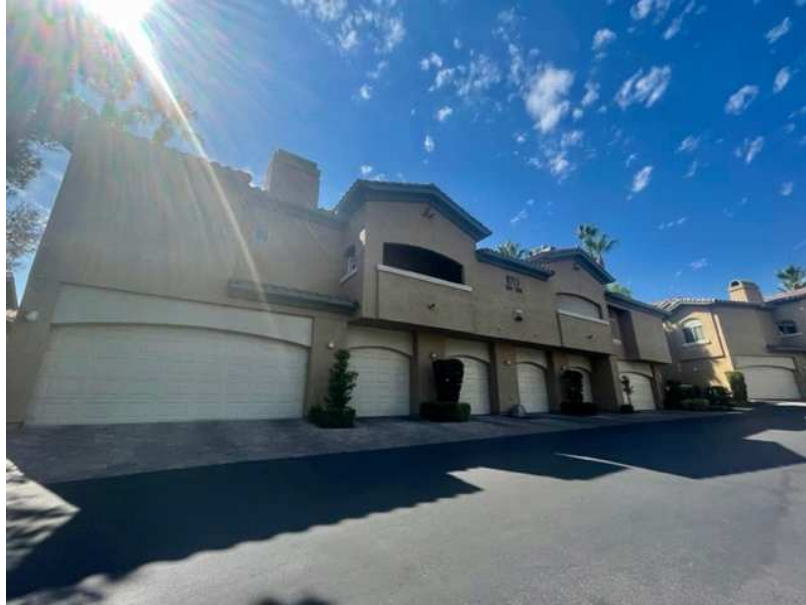
The Roof Replacement cost and estimated useful life was provided by PRS Roofing, Las Vegas, Nevada.

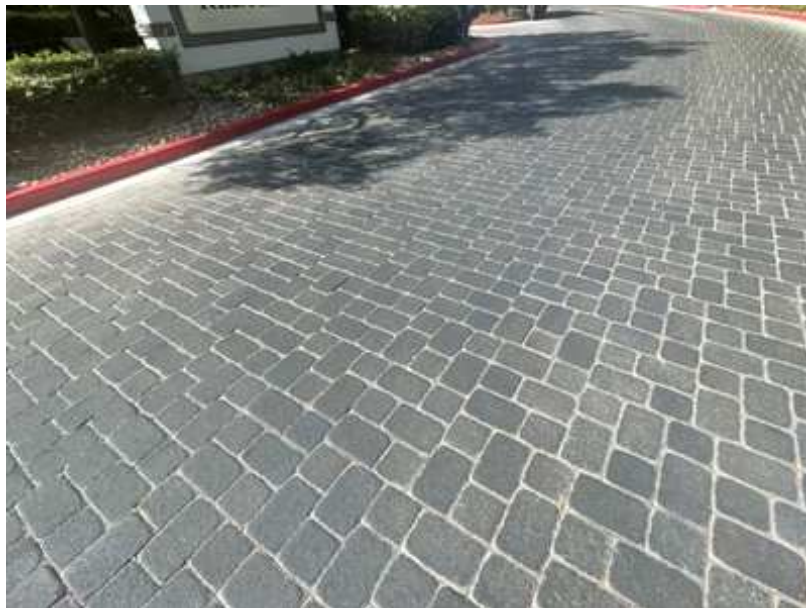
Complete replacement of all Pavers has not been included in the Study. Instead, repair and replacement has been scheduled as an allowance to be done as needed.

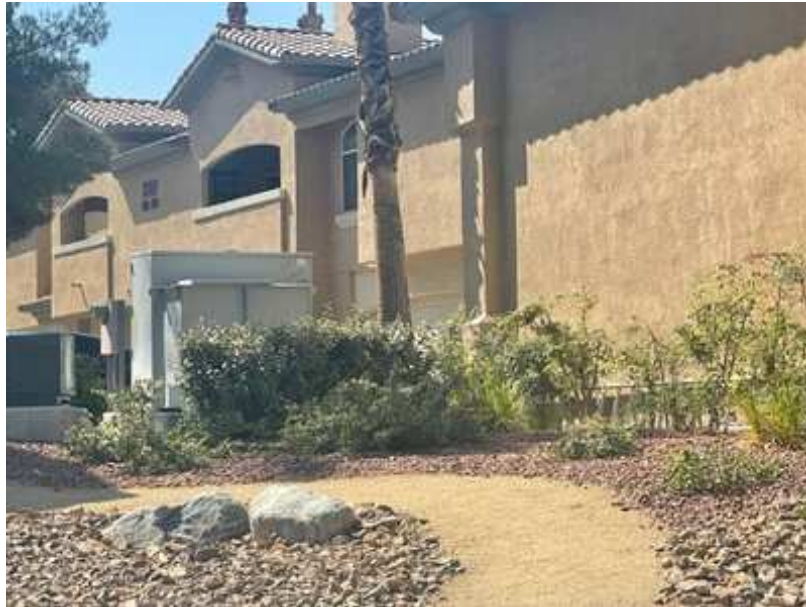
The Component “Rock Replenishment” has been included in the Study to be done as needed.

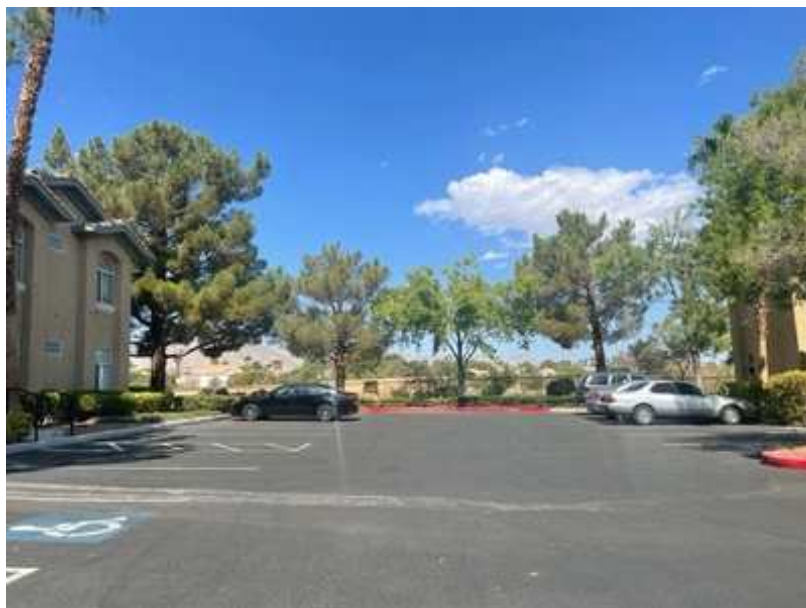
The Asphalt Road Maintenance Schedule includes the Surface Maintenance Treatment, Overlay and Crack Seal. This Schedule is an estimation only.

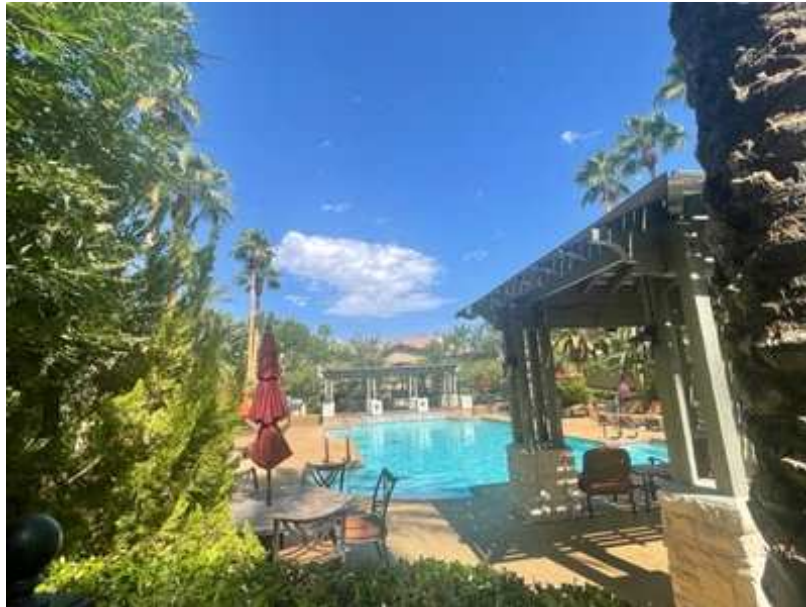
The Pool Area Components include the Wrought Iron Fencing, Shade Structure, Pool Concrete Deck Surface, Pool Furniture, Pool and Spa Re-Surface, Heater, Pump and Filter Replacement. The Useful Life of each component is an estimation only.

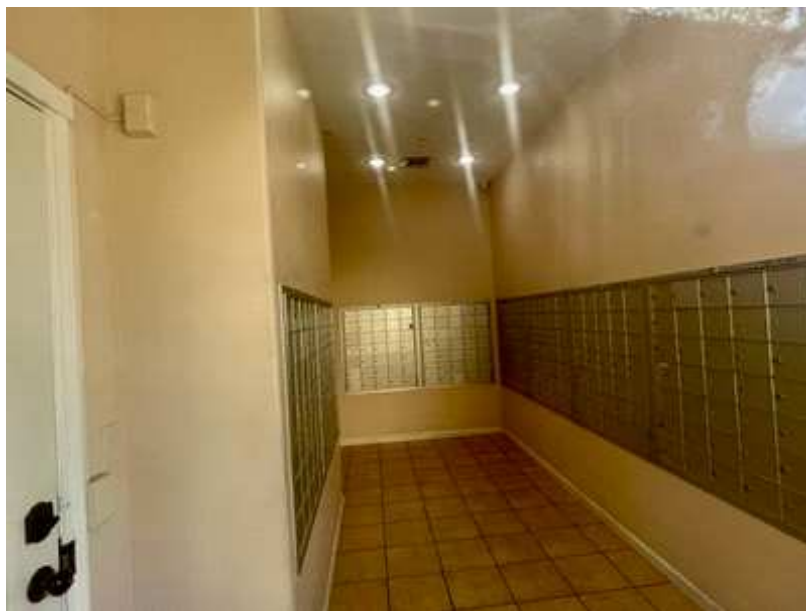
The Mail Boxes are Maintained by the Homeowners Association. The Estimated Useful Life when New is approximately 20 years. Replacement has been included in this Study.

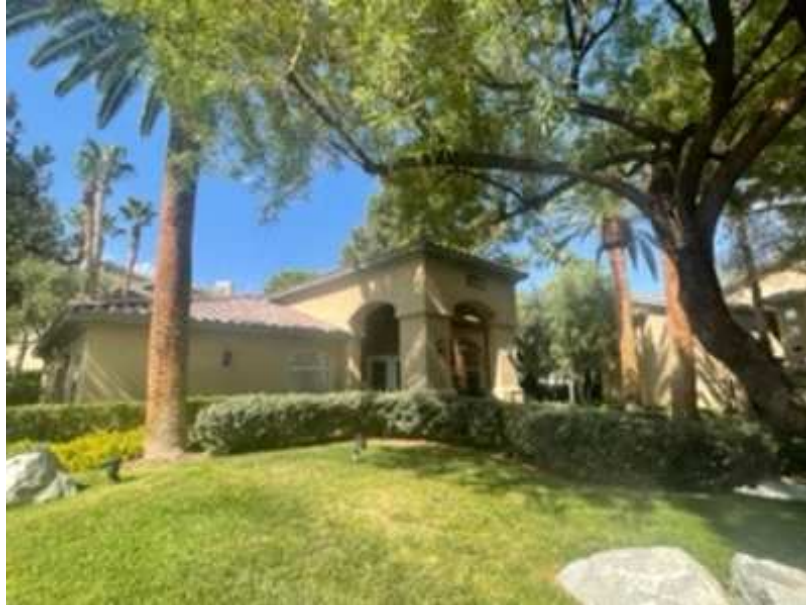
The Component Landscaping and Irrigation includes: Tree Removal and Replacement, Irrigation Repairs, Rock or Landscaping Renovation to be done as needed. Day-to-day Landscaping is considered an Operational Expense and has not been included in this Study.

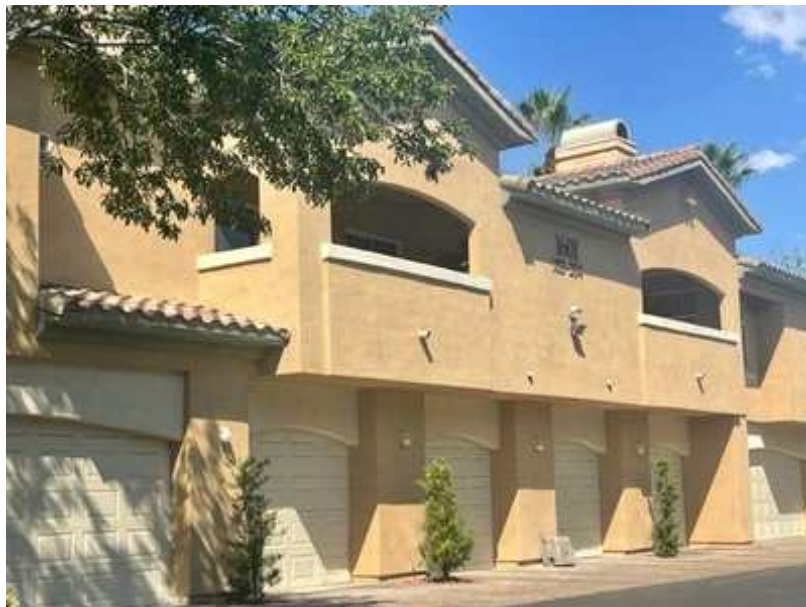
The Individual Owners are responsible for their Garage Doors. Replacement has not been included in the Study. Garage Doors are painted by the Homeowners Association when the Exterior of Homes are Painted.

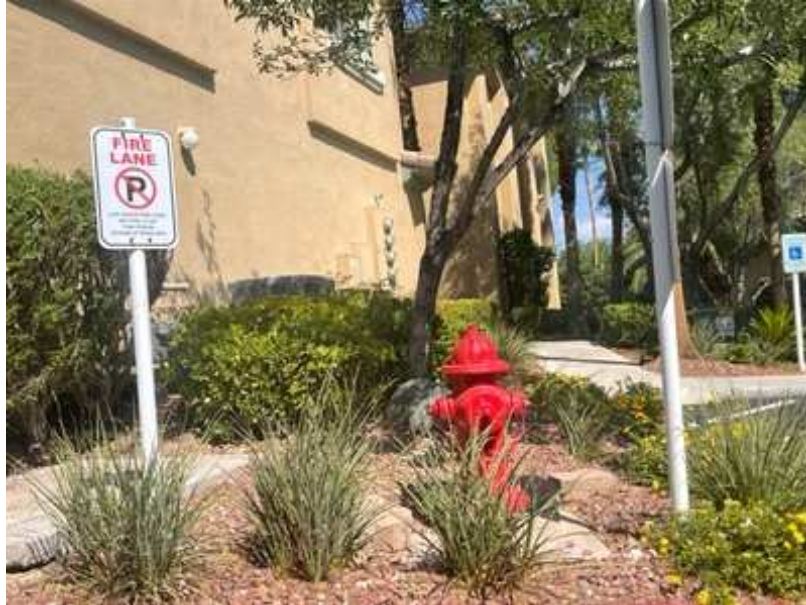
Fire Hydrants are maintained by the Association. Replacement has been included in the Reserve Study.

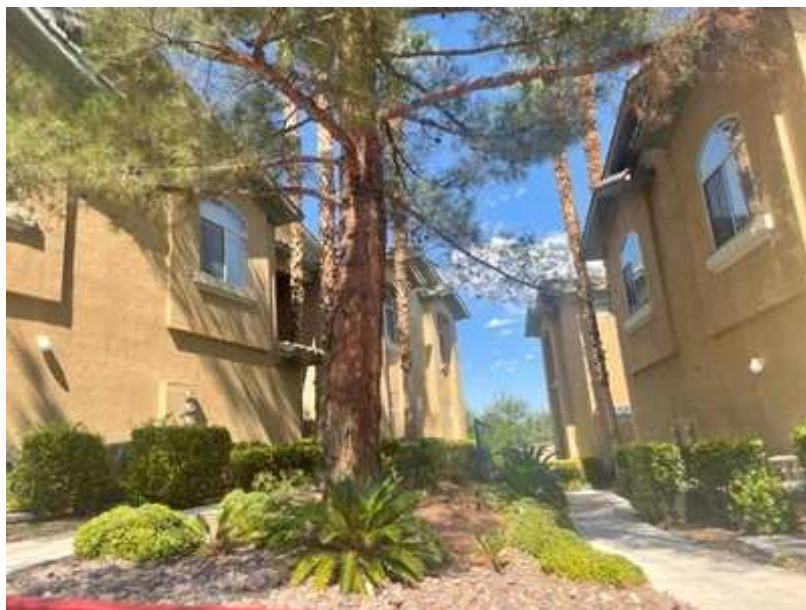
The Exterior of Homes Category includes the Tile Roof Underlayment Replacement, Exterior Painting and Stucco Repairs, Unit and Building Lighting, Building Signage and Paver Driveways. The Component Costs and Useful Life are an estimation only.

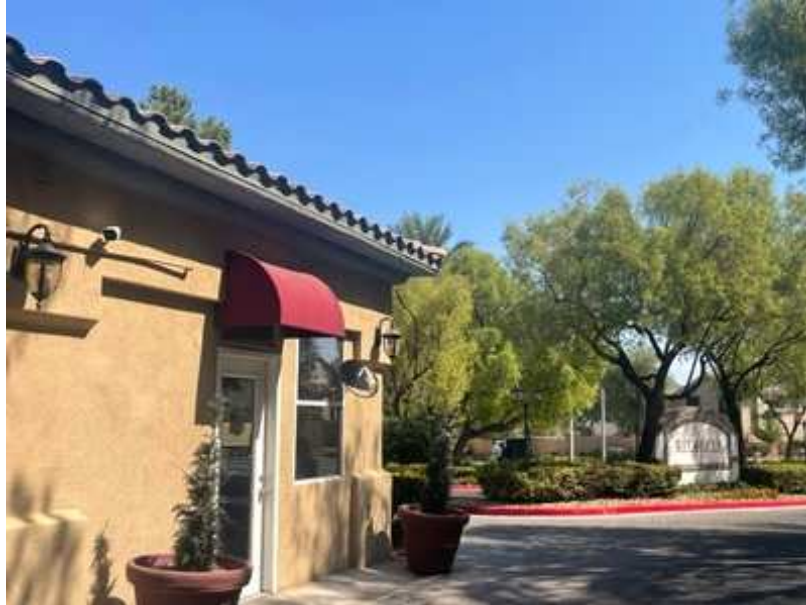
The Entrance Area Category Components include the Gate House, Gate Replacement, In Ground Loops, Loop Detectors, Motors, Pedestrian Gates and the Key Pad Entry System. The Gate Components Estimated Remaining Useful Life are an estimation only.

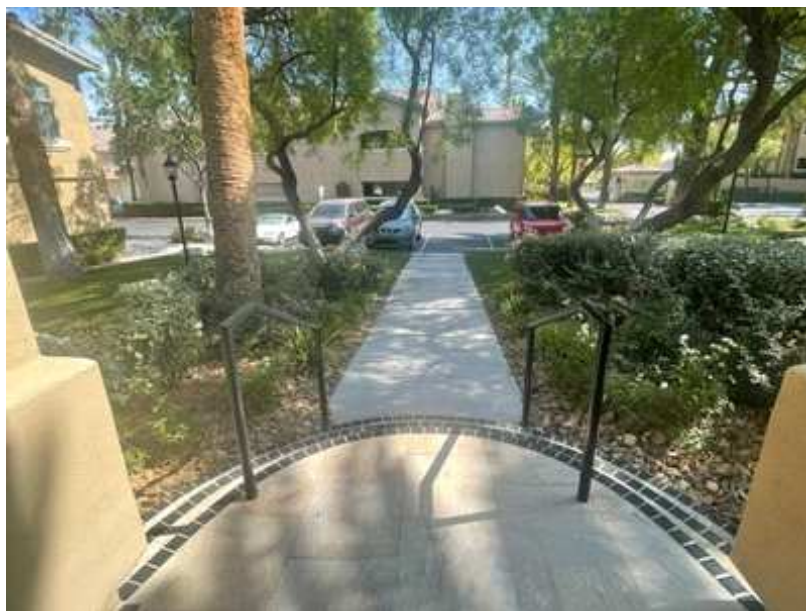
Complete replacement of all Concrete has not been included in the Study. Instead, repair and replacement has been scheduled as an allowance to be done as needed.

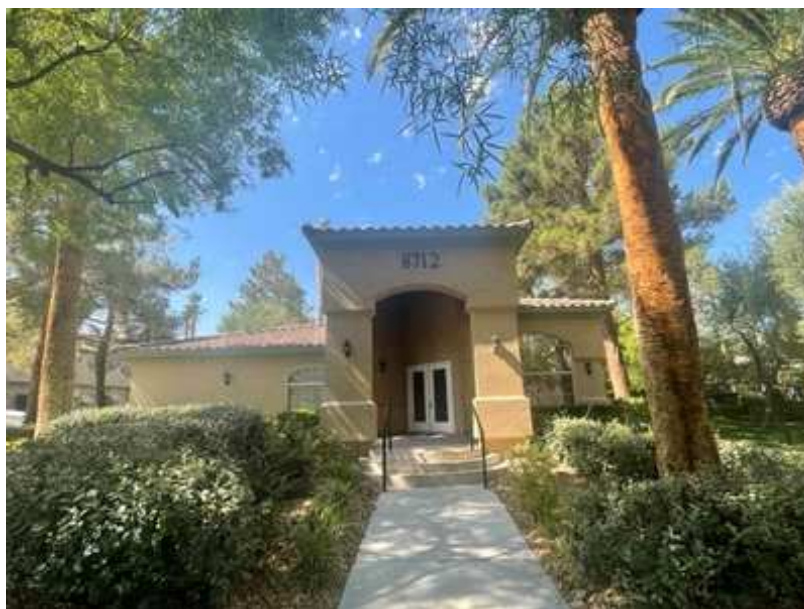
Clubhouse

Component	Year Scheduled	Quantity	Cost Per Unit	Today's Cost	Estimated Remaining Useful Life (Years)	Estimated Life When New (Years)
1. Art Work and Decorations	2026	allowance	\$2,000	\$2,000	4	5

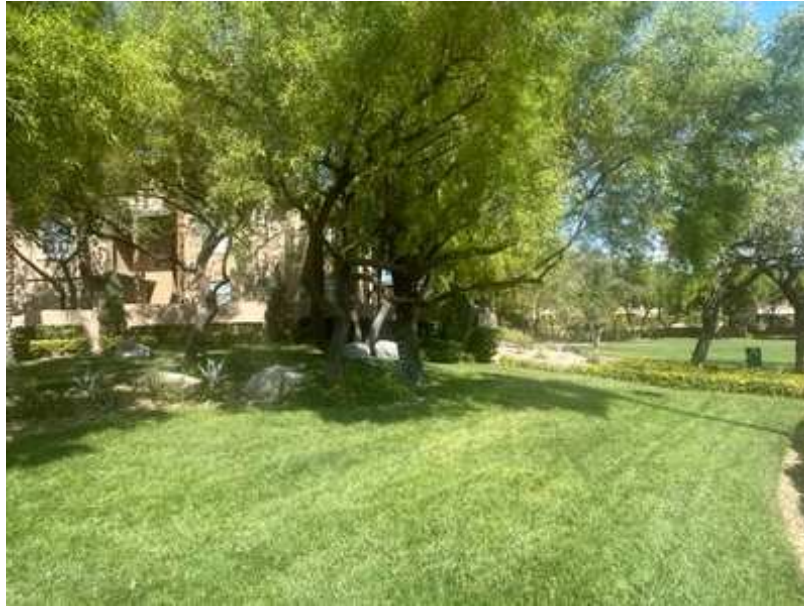
Common Area

Component	Year Scheduled	Quantity	Cost Per Unit	Today's Cost	Estimated Remaining Useful Life (Years)	Estimated Life When New (Years)
1. Concrete Repair or Replacement (Done 2022)	2022	allowance	\$6,406.25	\$6,406.25	0	3

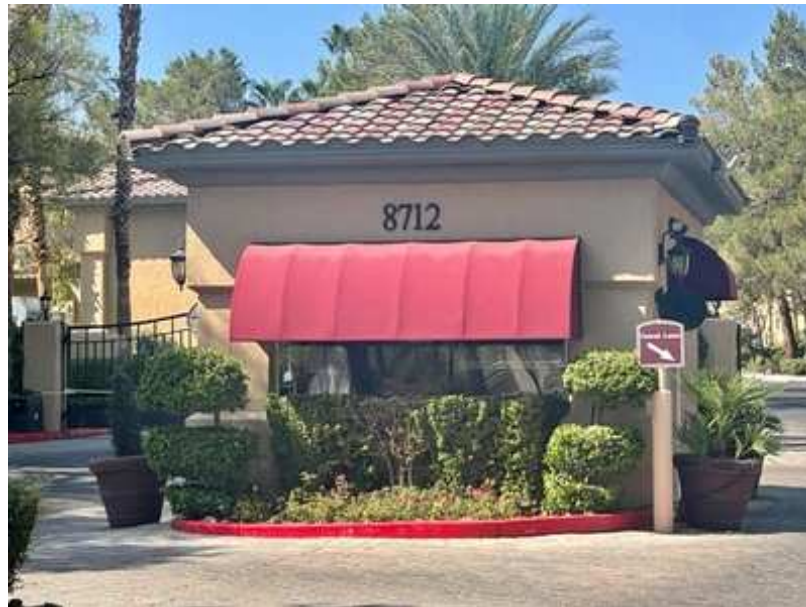
Entrance Area

Component	Year Scheduled	Quantity	Cost Per Unit	Today's Cost	Estimated Remaining Useful Life (Years)	Estimated Life When New (Years)
1. AVI Detectors	2023	as needed	\$2,500	\$2,500	1	5

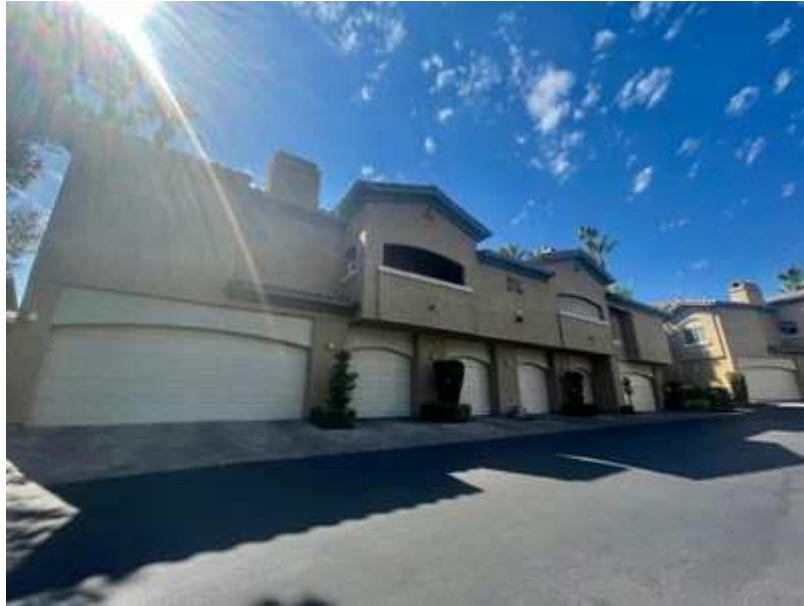
Exterior of Homes

Component	Year Scheduled	Quantity	Cost Per Unit	Today's Cost	Estimated Remaining Useful Life (Years)	Estimated Life When New (Years)
1. Lighting (9 Fixtures/Bldg, 2 Bldgs with 12 Fixtures)	2025	allowance	\$5,000	\$5,000	3	5

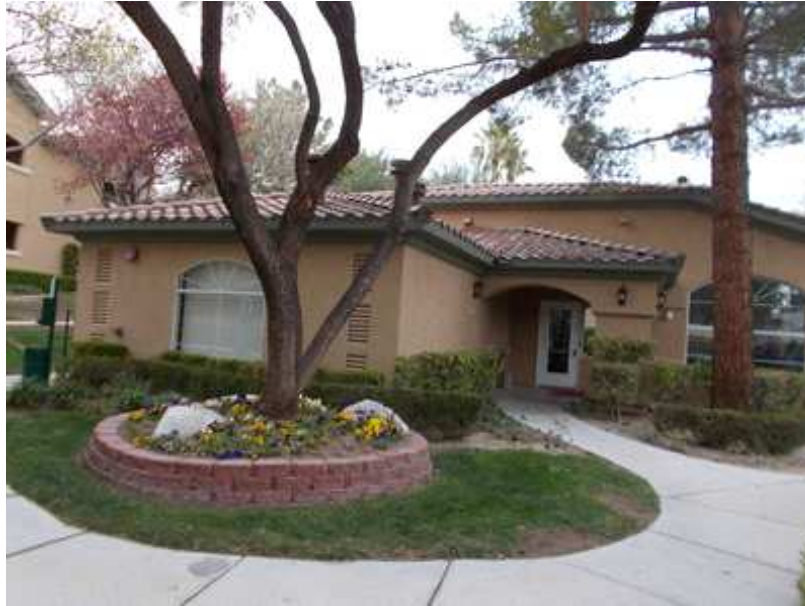
Fitness Building

Component	Year Scheduled	Quantity	Cost Per Unit	Today's Cost	Estimated Remaining Useful Life (Years)	Estimated Life When New (Years)
1. Dry Sauna Rehab	2030	2 units	\$12,000/unit	\$24,000	8	20

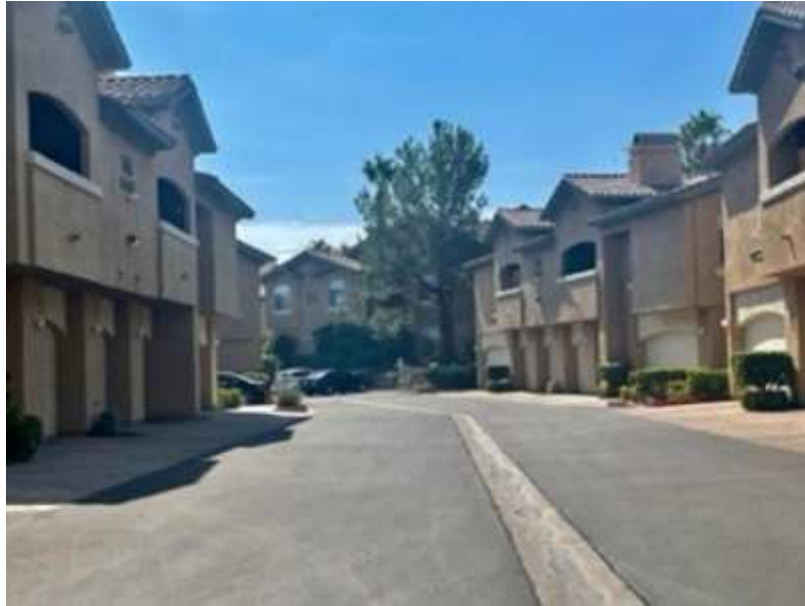
Roads and Parking

Component	Year Scheduled	Quantity	Cost Per Unit	Today's Cost	Estimated Remaining Useful Life (Years)	Estimated Life When New (Years)
1. Concrete Curbing and Parking Blocks	2024	allowance	\$5,000	\$5,000	2	3
2. Cut and Patch	2026	as needed	\$10,000	\$10,000	4	8
3. Fire Hydrant Replacement (12 Units Total)	2024	allowance	\$10,000	\$10,000	2	3
4. Overlay	2042	138902 sq ft	\$1.50/sq ft	\$208,353	20	30
5. Pavers Maintenance and Repair	2023	as needed	\$15,000	\$15,000	1	5
6. Street Signs Replacement	2026	allowance	\$2,500	\$2,500	4	5
7. Striping , Curb and Fire Hydrant Painting	2023	as needed	\$6,500	\$6,500	1	5
8. Surface Maintenance Treatment Crack Seal and Striping	2023	138902 sq ft	\$.25/sq ft	\$34,725.50	1	5
