# Navigating Capital Expenditure Projects

We are a full-service capital expenditure consulting firm. Our specialties include roofing, paving, ADA upgrades, siding, foundations and large project management. Our commitment is to **PROTECT** our clients.

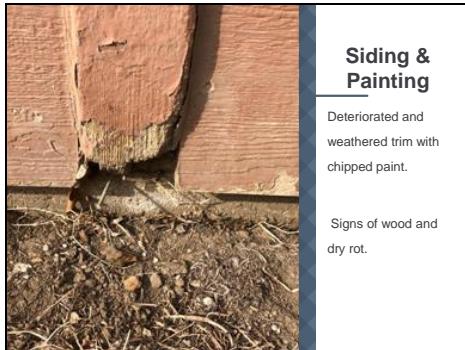
## Siding & Painting

Deteriorated and weathered trim with chipped paint.

Signs of wood and dry rot.

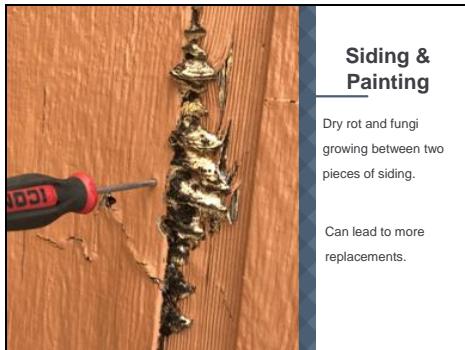
## Siding & Painting

Dry rot and fungi growing between two pieces of siding.

Can lead to more  
replacements.

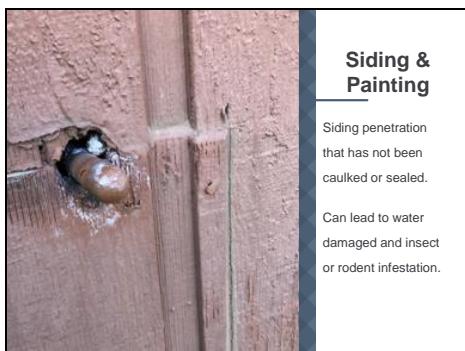
## Siding & Painting

Siding penetration  
that has not been  
caulked or sealed.

Can lead to water  
damaged and insect  
or rodent infestation.

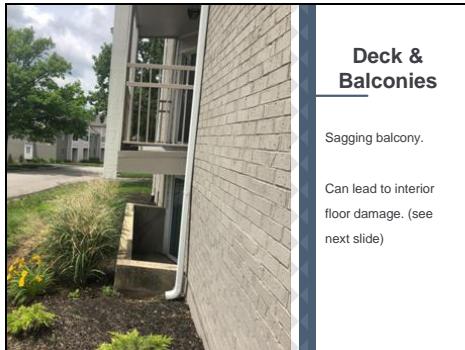
## Deck & Balconies

### Sagging balcony.

Can lead to interior  
floor damage. (see  
next slide)

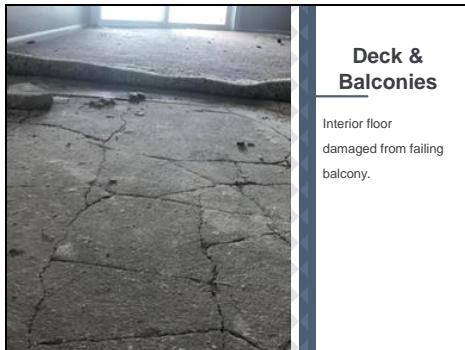
## Deck & Balconies

Interior floor  
damaged from failing  
balcony.

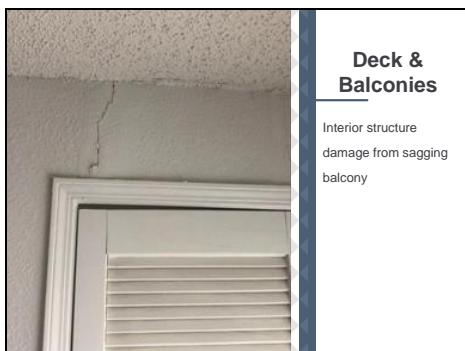
## Deck & Balconies

Interior structure  
damage from sagging  
balcony

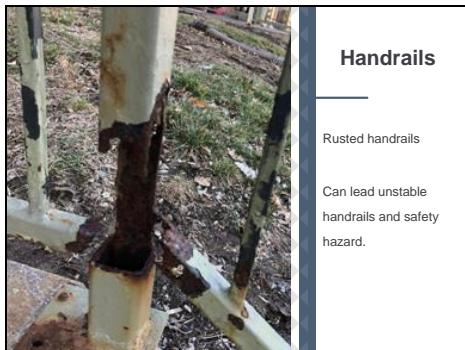
## Handrails

## Rusted handrails

Can lead unstable handrails and safety hazard.

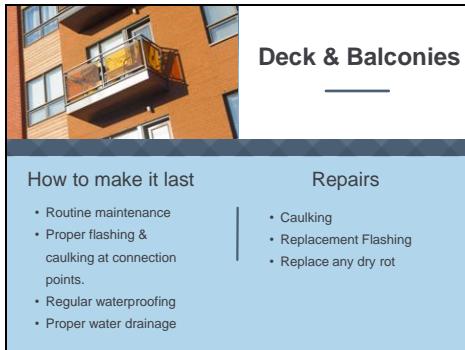
## Deck & Balconies

## How to make it last

- Routine maintenance
- Proper flashing & caulking at connection points.
- Regular waterproofing
- Proper water drainage

## Repairs

- Caulking
- Replacement Flashing
- Replace any dry rot

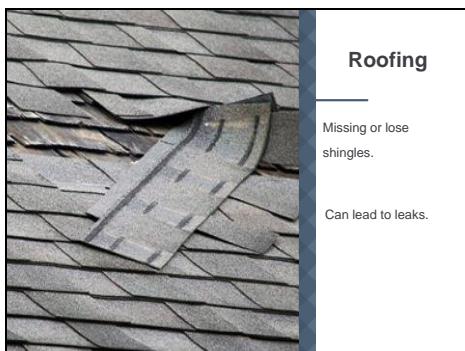
## Roofing

Missing or loose  
shingles.

Can lead to leaks

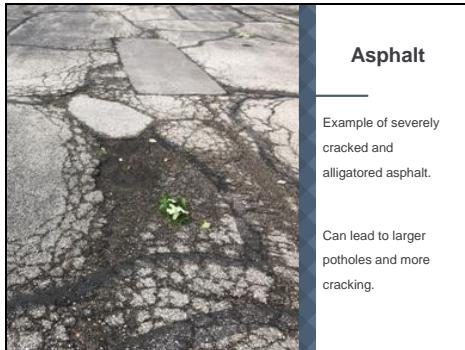
## Asphalt

Example of severely cracked and alligatorated asphalt.

Can lead to larger potholes and more cracking.

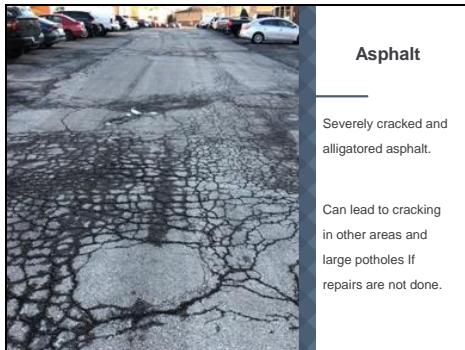
## Asphalt

Severely cracked and  
alligatorated asphalt.

Can lead to cracking  
in other areas and  
large potholes If  
repairs are not done.

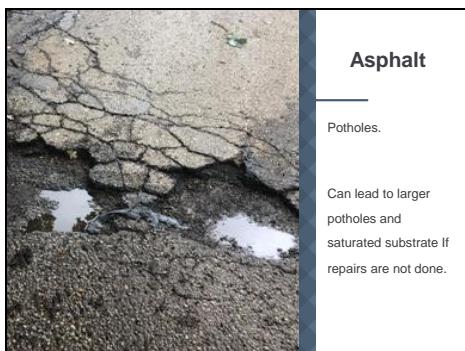
## Asphalt

Can lead to larger potholes and saturated substrate If repairs are not done.
