# Sample Church Reserve Study

## Full Reserve Study

Prepared for Year: 07/01/2026 - 06/30/2027

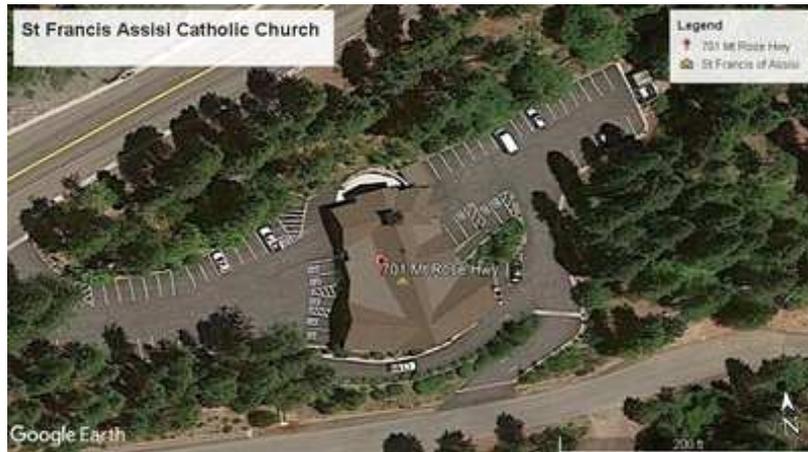
The Roof Replacement Costs and Remaining Useful Life are an estimation only. Further evaluation by a Roofing Inspector is strongly recommended. This Study should be updated with the results of the inspection.

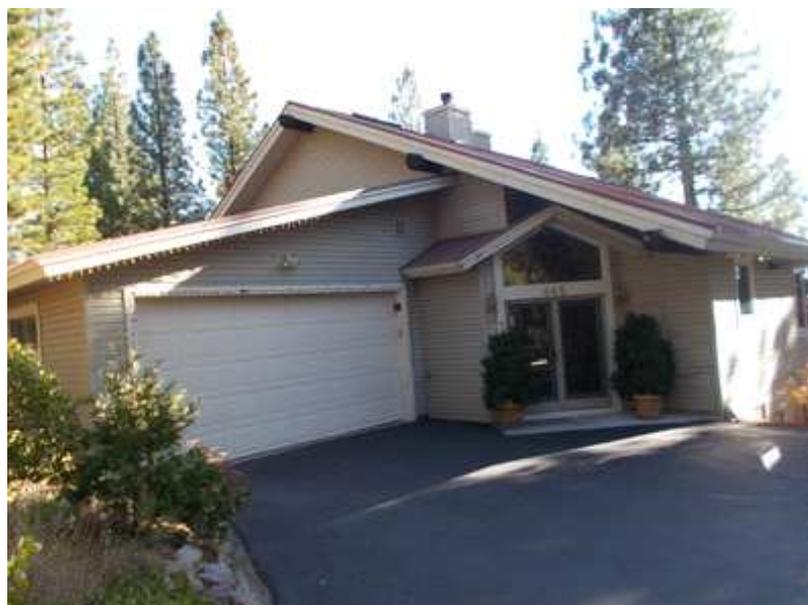
The Rectory Exterior Components include Vinyl Siding Repairs, Roof Maintenance, Roof Replacement, Deck Staining and Repairs and Garage Door Replacement. The Vinyl Siding has an Estimated Useful Life When New of 40-50 Years. Replacement has not been scheduled.

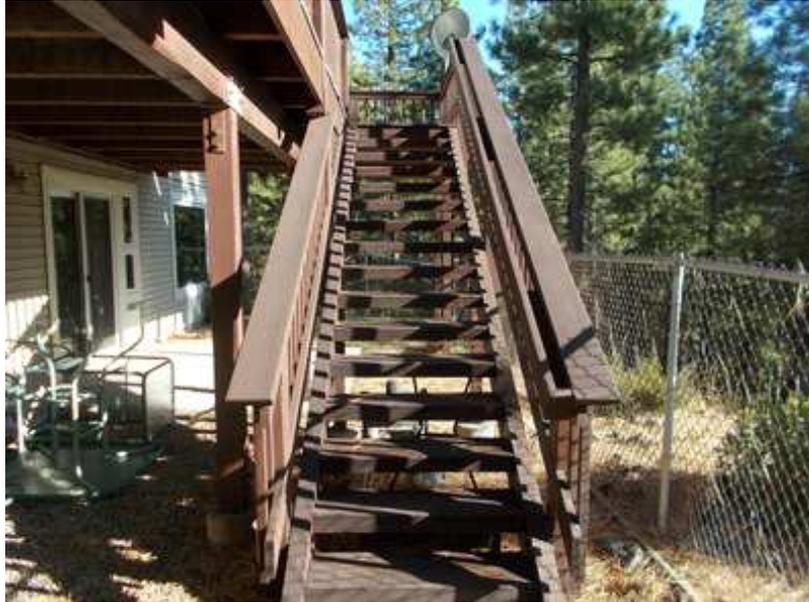
Staining and Repairs of the Exterior Stairs and Deck has been included in the Study. The Trex Deck Surface has an Estimated Useful Life when new of 20 Years. Future Replacement has been included in the Study.

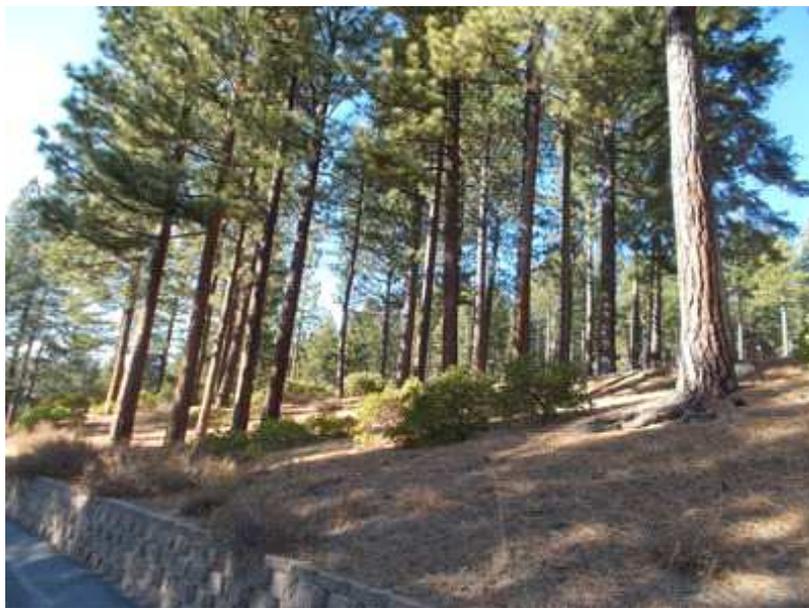
The Component Major Landscaping and Irrigation includes: Tree Removal and Replacement, Major Irrigation Repairs, Rock or Landscaping Renovation to be done as needed. Day-to-day Landscaping is considered an Operational Expense and has not been included in this Study.

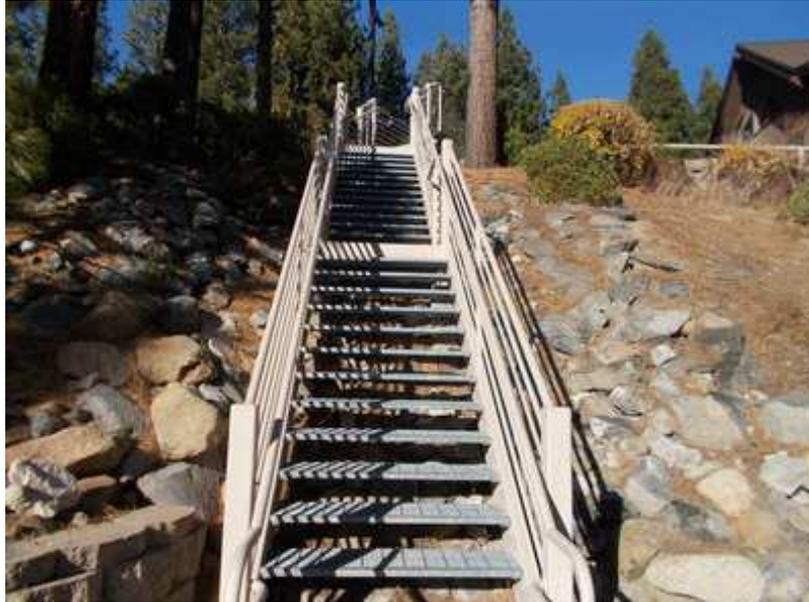
Maintenance of the Stairs to the Rectory and Lower Level is done by the Maintenance Staff. The Estimated Useful Life of the Staircase is 40 years. Replacement has not been included in the Study.

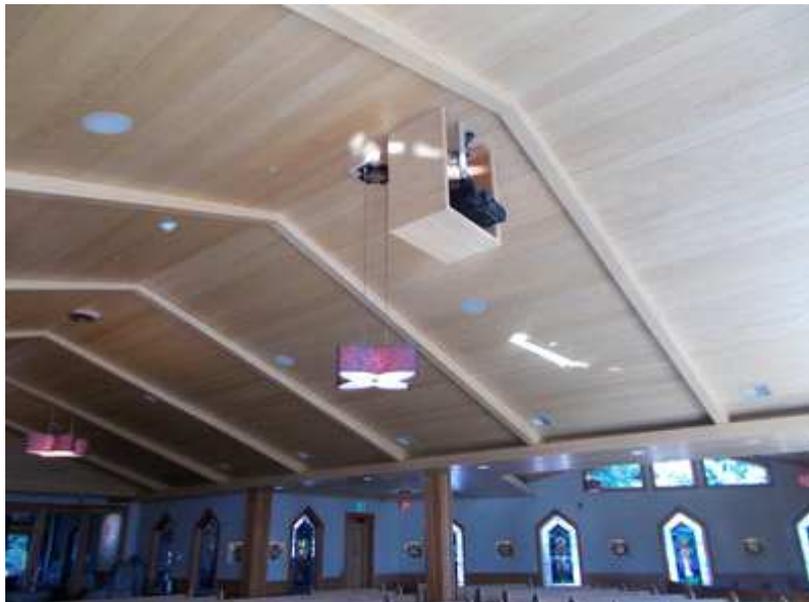
The Projector, Screen, Sound System and Choir Sound Board are included as Components in the Study.

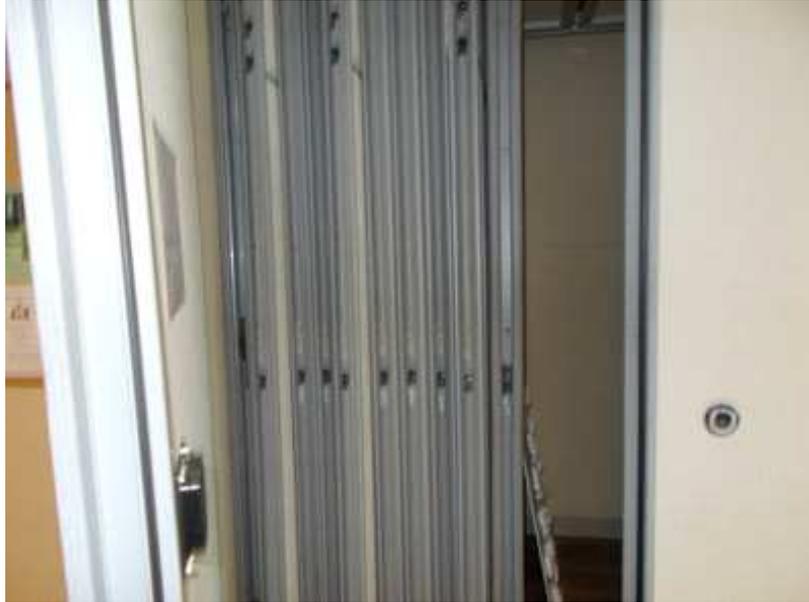
The Room Dividers have an Estimated Useful Life of 20 years. Replacement has been included in the Study.

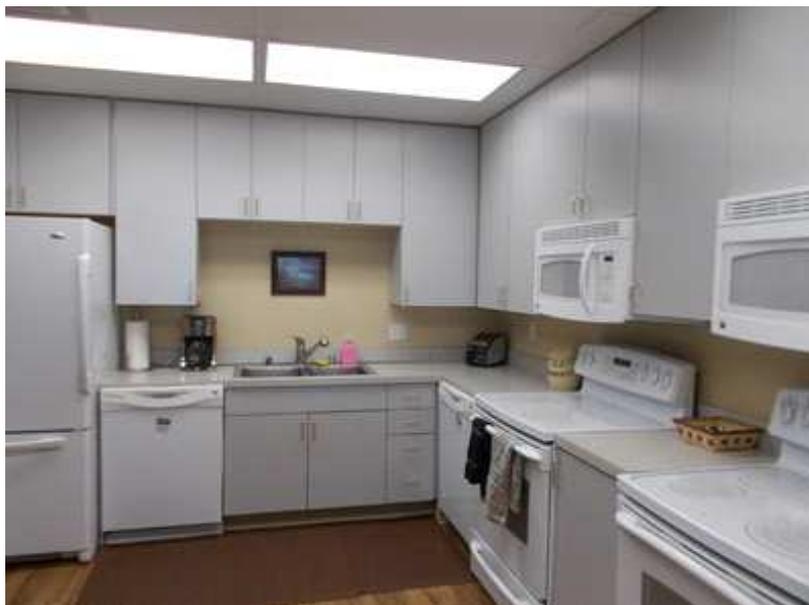
The Kitchen Remodel has been included in the Study to be done as needed. Appliance Replacement is scheduled to be done as needed through a Contingency Fund.

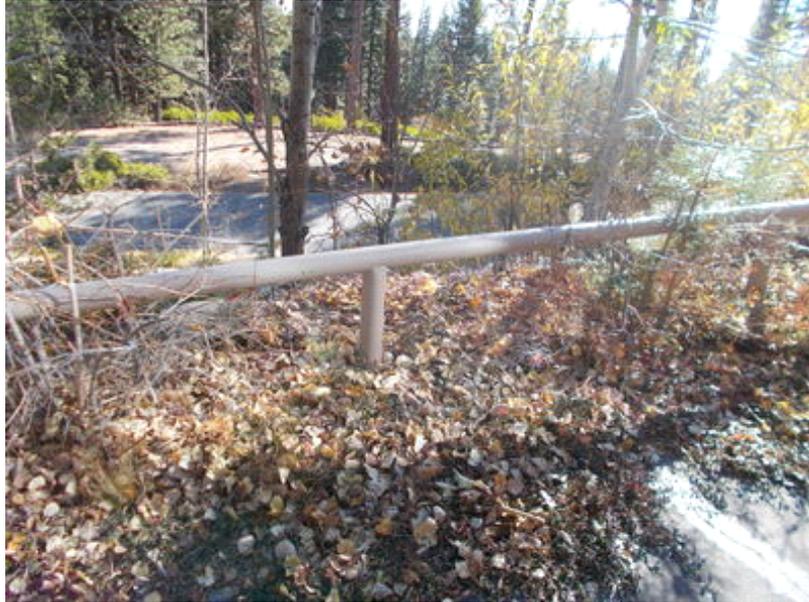
Painting and Repairs of the Metal Handrails is done by the Maintenance Staff and is considered an Operating Expense.

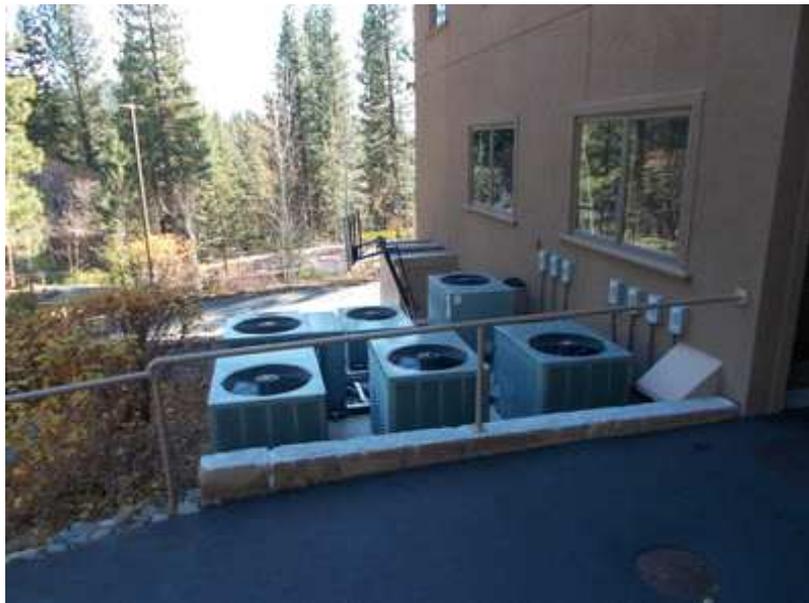
Replacement of the AC Units has been included in the Study. The Estimated Useful Life When New is 20 years.

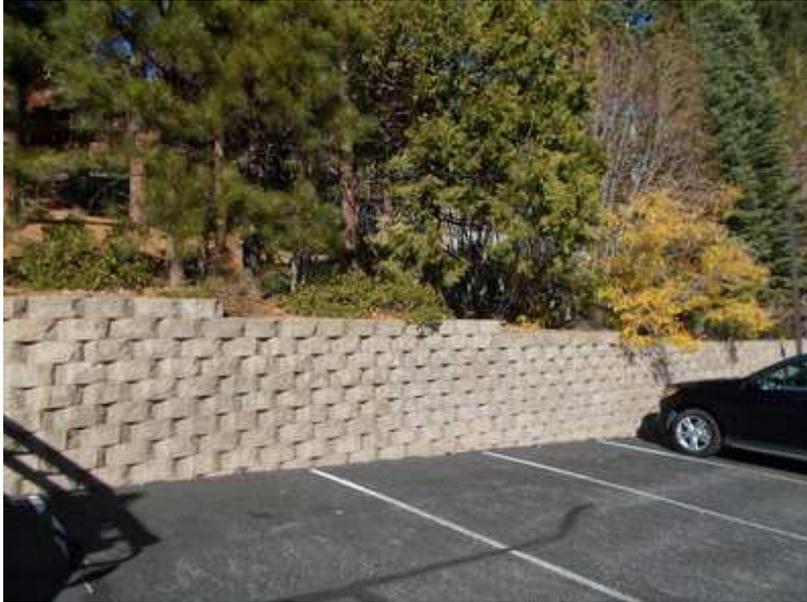
The Retaining Wall has an estimated useful life of more than 30 years. Replacement has not been included in the Study. Periodic Inspection by an Engineer is recommended to ensure the Wall's integrity.

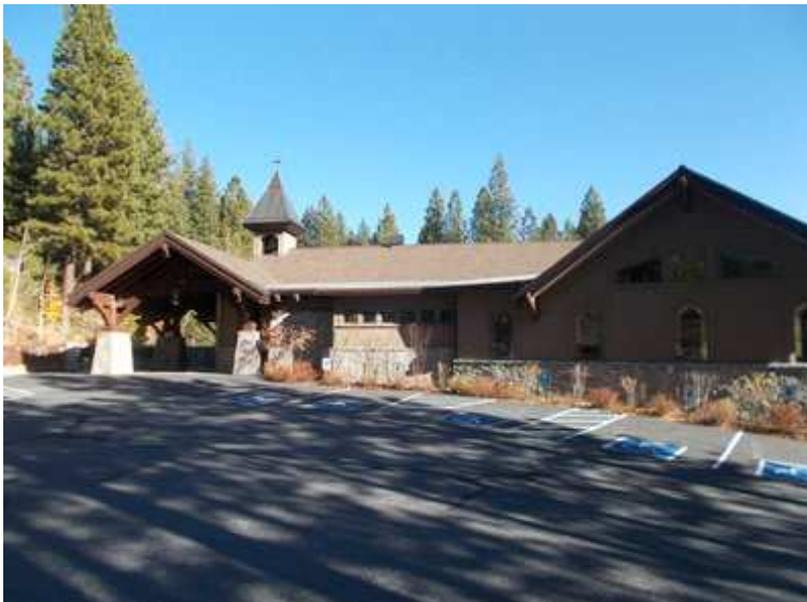
The Building Exterior Components include the Roof Replacement, Stucco Painting and Repairs, Ice Melt System, Exterior Lighting and Gutter Repairs.

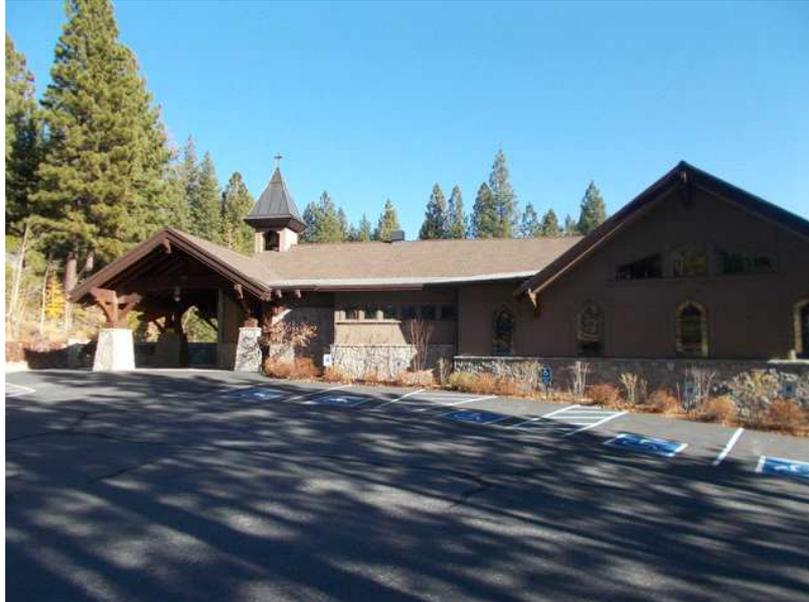
The Church and Rectory are in overall good condition and very well maintained.

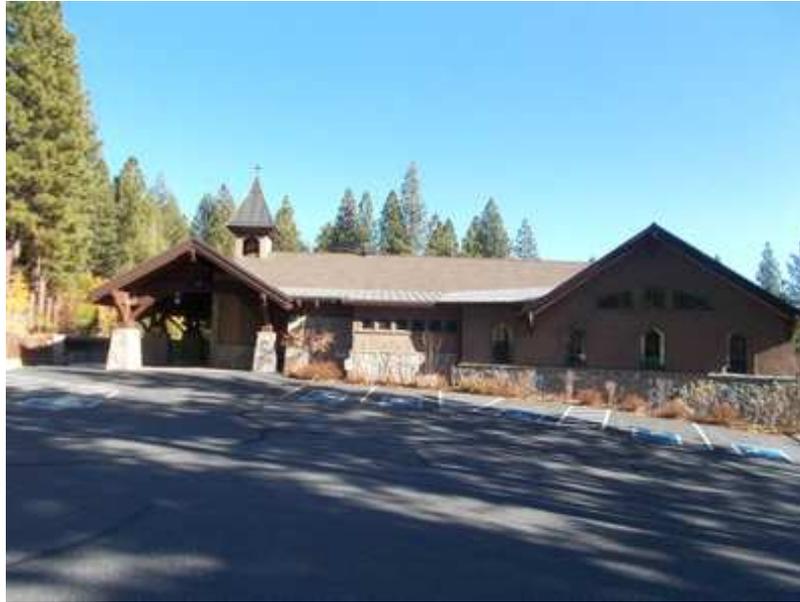
### Building Exterior

Component	Year Scheduled	Unit of Measure	Cost Per Unit	Today's Cost	Estimated Remaining Useful Life (Years)	Estimated Life When New (Years)
1. Church Statues	2037	as needed	\$5,400	\$5,400	12	20
2. Gutters and Downspouts Repair or Replacement Contingency	2026	as needed	\$2,700	\$2,700	1	5
3. Ice Melt System Rehab	2032	as needed	\$6,500	\$6,500	7	20
5. Lighting Contingency	2026	as needed	\$1,700	\$1,700	1	5
4. Lighting -Front Fixtures	2032	as needed	\$860	\$6,020	7	20
6. Roof Replacement (Includes Removal and Disposal of Current Shingles)	2042	14500 sq ft	\$9.15/sq ft	\$132,675	17	30
7. Stucco Painting and Repairs (New 2008)	2029	as needed	\$26,900	\$26,900	4	15

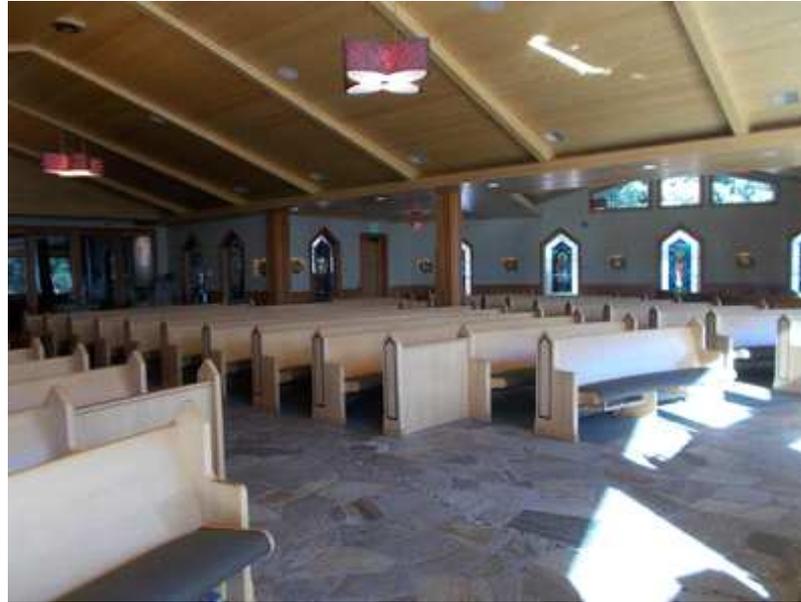
### Building Interior

Component	Year Scheduled	Unit of Measure	Cost Per Unit	Today's Cost	Estimated Remaining Useful Life (Years)	Estimated Life When New (Years)
1. Appliance Replacement Contingency	2027	as needed	\$5,400	\$5,400	2	3

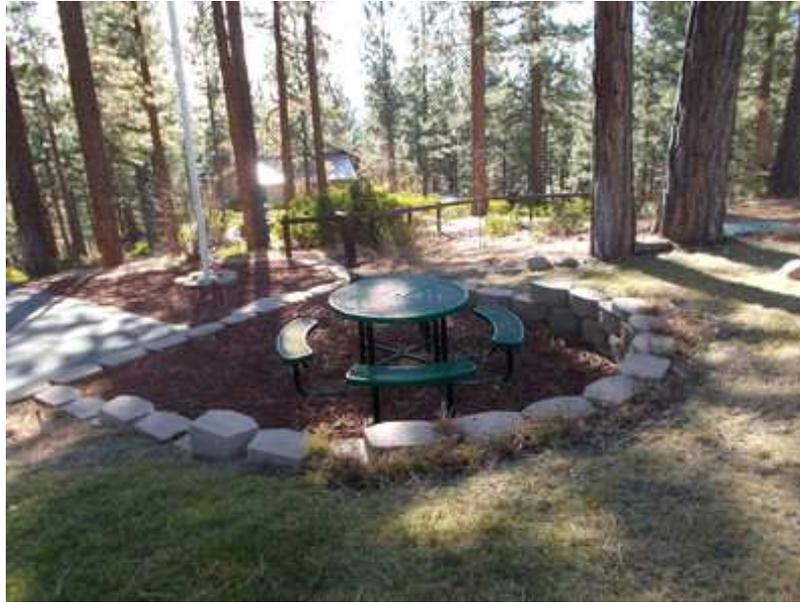
### Common Area

Component	Year Scheduled	Unit of Measure	Cost Per Unit	Today's Cost	Estimated Remaining Useful Life (Years)	Estimated Life When New (Years)
1. Entrance Sign	2032	1 unit	\$5,900	\$5,900	7	20
2. Flag Pole	2032	1 unit	\$2,700	\$2,700	7	20
4. Landscaping and Irrigation Renovation	2027	as needed	\$5,400	\$5,400	2	3
3. Landscaping -Trees Contingency	2027	as needed	\$5,400	\$5,400	2	3
5. Lighting and Electrical Contingency	2026	as needed	\$1,700	\$1,700	1	5
6. Park Bench	2027	1 unit	\$1,100	\$1,100	2	10
7. Picnic Tables	2027	1 unit	\$1,700	\$1,700	2	10

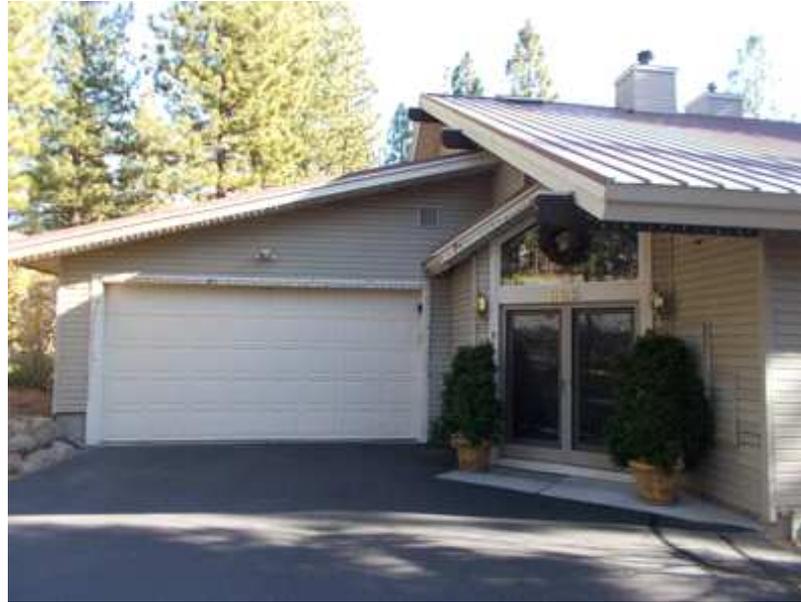
### Rectory

Component	Year Scheduled	Unit of Measure	Cost Per Unit	Today's Cost	Estimated Remaining Useful Life (Years)	Estimated Life When New (Years)
1. Exterior -Bear Trash Can	2032	1 unit	\$1,100	\$1,100	7	20

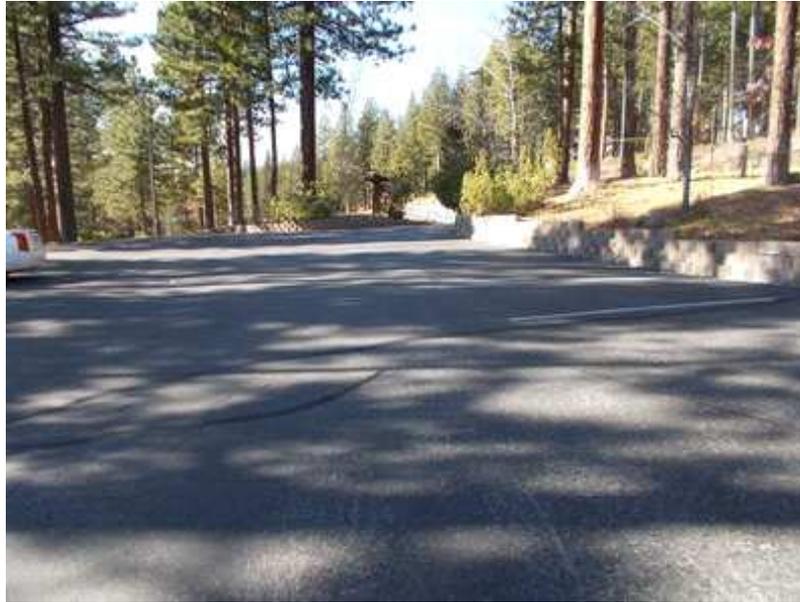
### Roads and Parking

Component	Year Scheduled	Unit of Measure	Cost Per Unit	Today's Cost	Estimated Remaining Useful Life (Years)	Estimated Life When New (Years)
1. Cut and Patch /Repairs Contingency	2031	as needed	\$10,800	\$10,800	6	10
2. Overlay -Parking Lot and Rectory Driveway	2037	32300 sq ft	\$2.15/sq ft	\$69,445	12	30
3. Surface Maintenance Treatment -Parking Lot and Rectory Driveway	2026	32300 sq ft	\$.27/sq ft	\$8,688.70	1	4
