Sample 2027 Business Association

Reserve Study Annual Update

Prepared for Year: 01/01/2026 - 12/31/2026

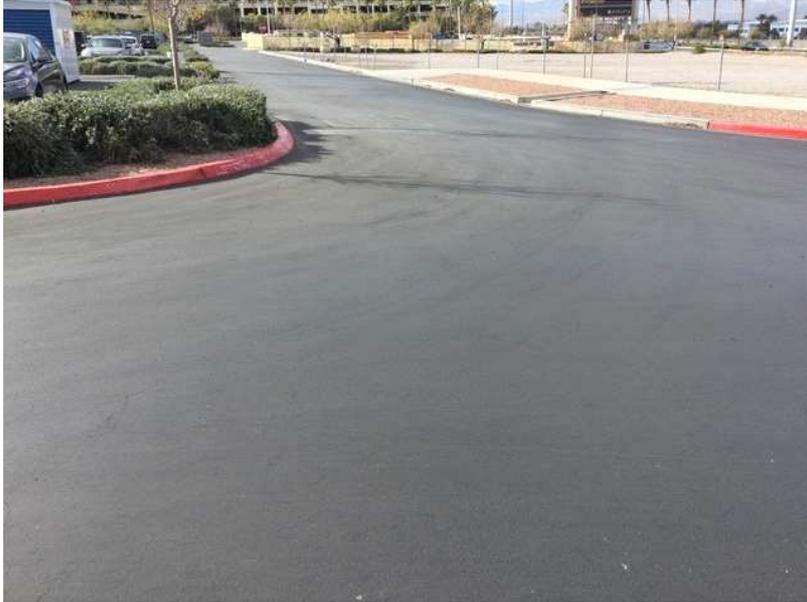
The Asphalt Road Maintenance Schedule includes the Surface Maintenance Treatment, Overlay, Crack Seal, Concrete Curbing Repairs and Striping and Curb Painting. This Schedule is an estimation only.

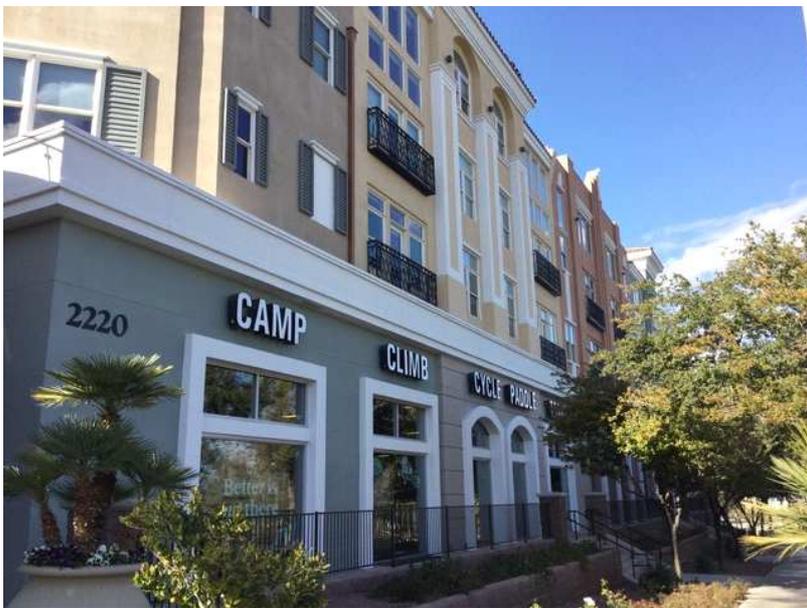
Exterior Building Painting is scheduled to be done every 10 years. The cost is based on information provided by the Association.

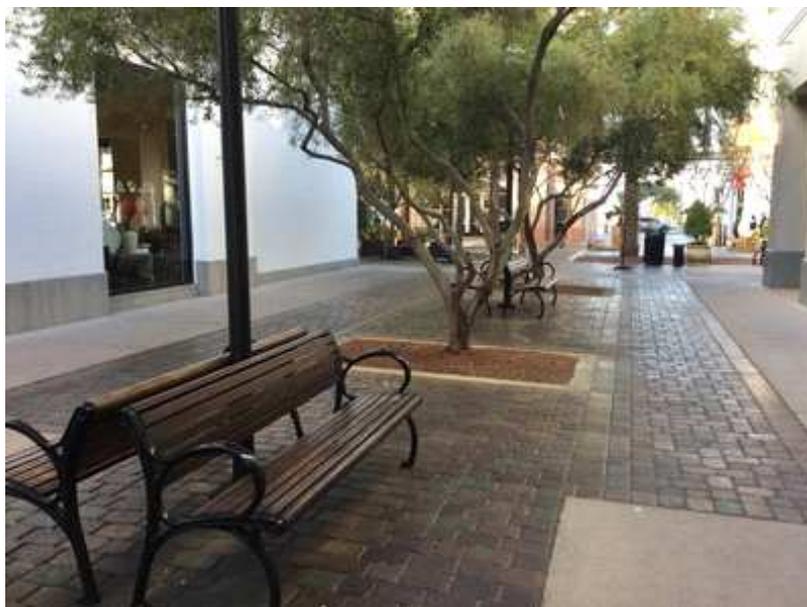
Replacement of the Park Furnishings have been included in the Study. The cost and useful life are an estimation only.

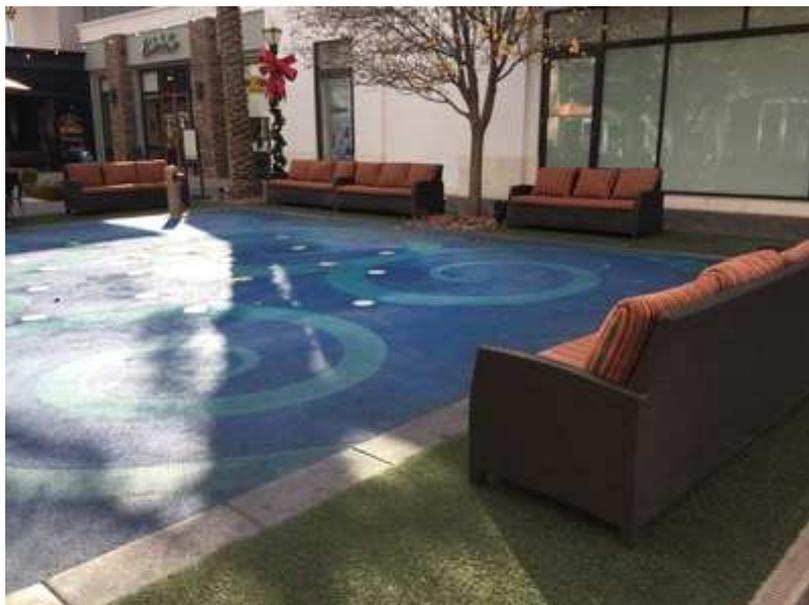
Replacement of the splash pad has been included in the Study. The cost and remaining useful life are an estimation only.

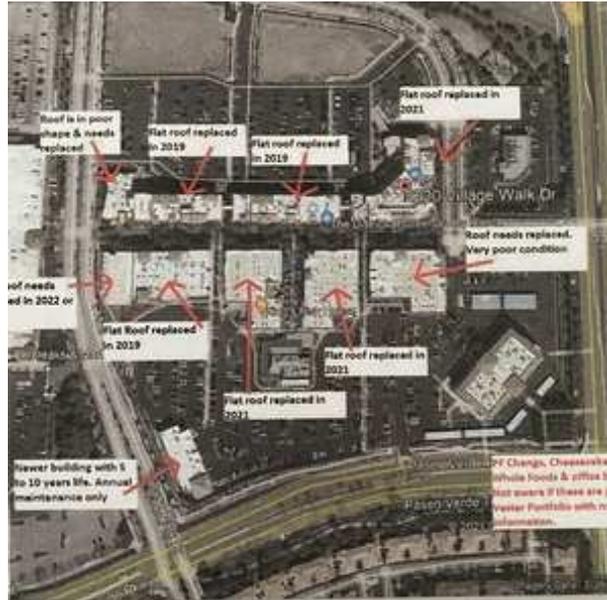
The Roof Costs and Remaining Useful Life are an estimation only. A Roof Inspection to determine the useful life and cost of replacement is strongly recommended and has been included in this Study. This Study should be updated with the results of the Inspection. This map of the roof was provided by the management company. This study is for (Buildings 2220/2240/2260) Only.

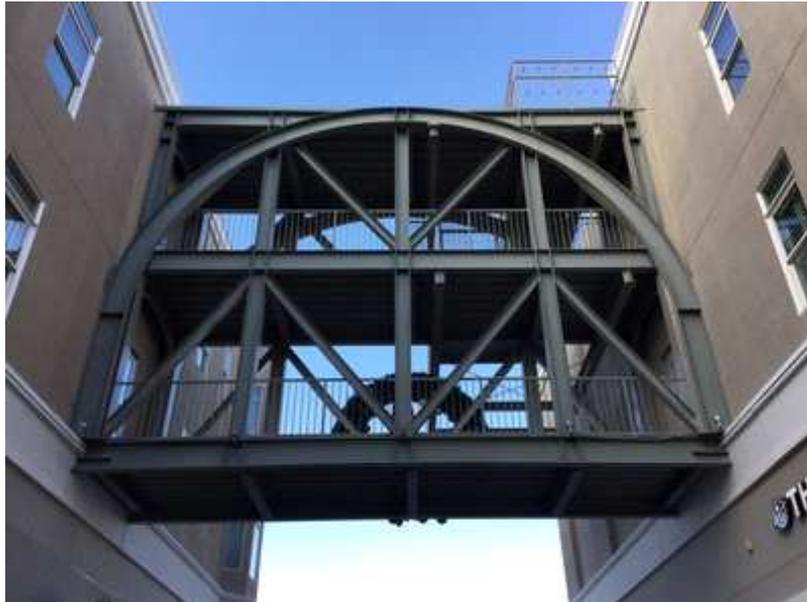
The Breezeway Structure is made of metal and has an estimated useful life of more than 30 years. Replacement has not been included in this Study. Repairs and Painting have been scheduled every 5-7 years. An engineering evaluation has been scheduled in the study.

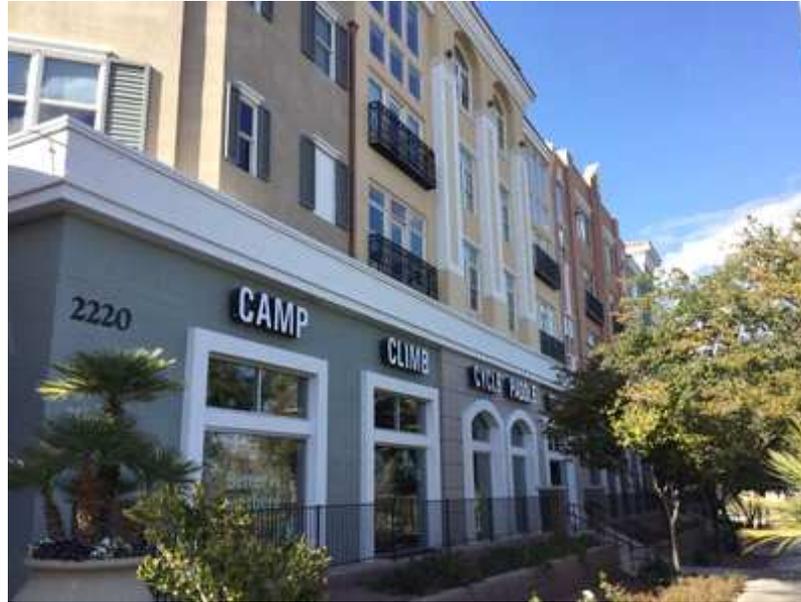
Building Exterior

Component	Year Scheduled	Unit of Measure	Cost Per Unit	Today's Cost	Estimated Remaining Useful Life (Years)	Estimated Life When New (Years)
1. Painting Building 2220 (Done 2024)	2034	1 bldg	\$258,000	\$258,000	9	10

7. Roof Replacement- Building 2240 (TPO Membrane) (Done 2019)	2039	22550 sq ft	\$6.70/sq ft	\$151,085	14	20
8. Roof Replacement- Building 2260 (Tile Underlayment) (Done 2019)	2039	6580 sq ft	\$4.64/sq ft	\$30,531.20	14	20

9. Roof Replacement- Building 2260 (TPO Membrane) (Done 2019)	2039	16400 sq ft	\$6.70/sq ft	\$109,880	14	20

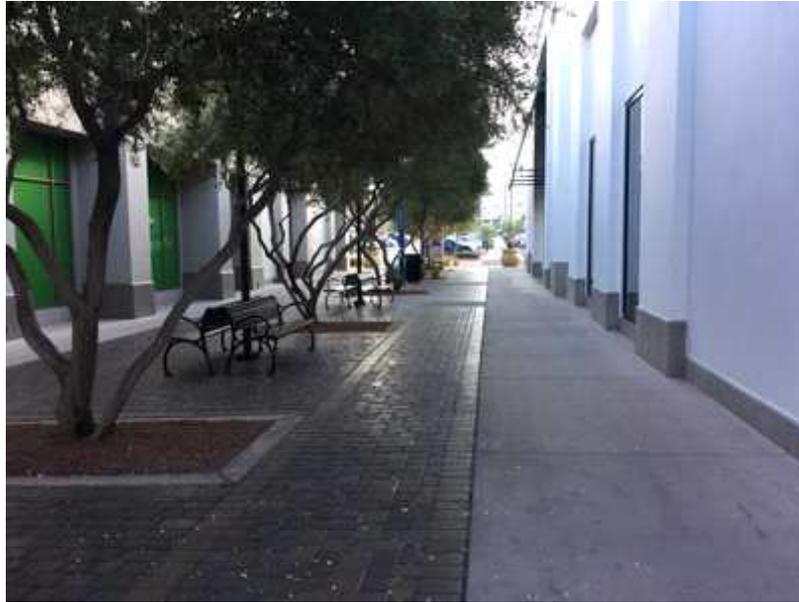
Common Area

Component	Year Scheduled	Unit of Measure	Cost Per Unit	Today's Cost	Estimated Remaining Useful Life (Years)	Estimated Life When New (Years)
1. Directory Signage Replacement (Operating Expense)	2026	as needed	\$	\$0	1	20
3. Landscaping Renovation - Main Street (Done 2023)	2035	as needed	\$200,000	\$200,000	10	12
2. Landscaping Renovation (Done 2025)	2045	as needed	\$600,000	\$600,000	20	20
4. Monument Pylon Signage (Large) Retrofit LED, Restructure, and Paint (Done 2024)	2044	1 unit	\$129,000	\$129,000	19	20
5. Monument Signage (Small) Renovation (Operating Expense)	2055	1 unit	\$	\$0	30	30
6. Park Furniture (All Seating) Replacement	2026	as needed	\$200,000	\$200,000	1	15
7. Park Furniture (All Seating) Replacement (Done 2025)	2040	as needed	\$100,000	\$100,000	15	15
8. Water Splash Pad Repairs or Replacement	2030	1 unit	\$36,000	\$36,000	5	10

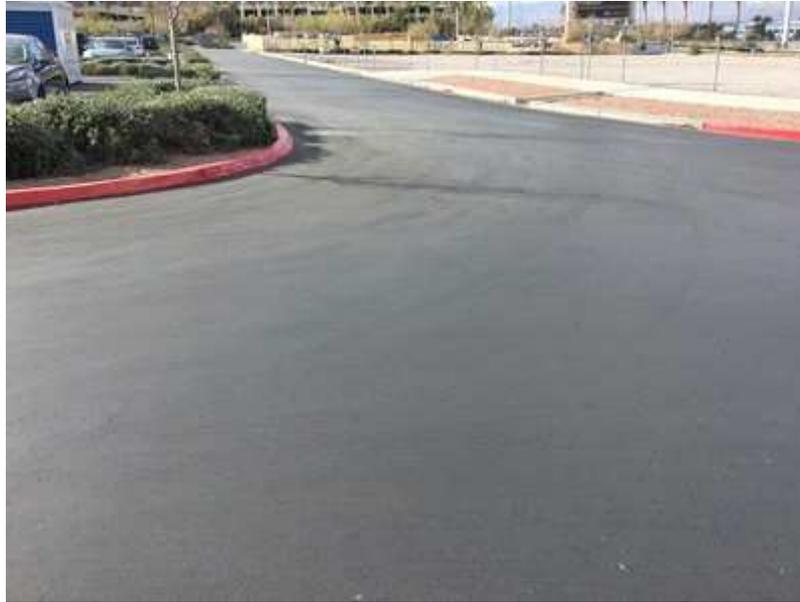
Roads and Parking

Component	Year Scheduled	Unit of Measure	Cost Per Unit	Today's Cost	Estimated Remaining Useful Life (Years)	Estimated Life When New (Years)
1. Asphalt Overlay	2043	439830 sq ft	\$1.54/sq ft	\$677,338.20	18	30
2. Fire Hydrants Replacement	2044	15 units	\$9,250/unit	\$138,750	19	40
3. Street Lights and Parking Lot Lights (Operating Expense)	2055	as needed	\$	\$0	30	30
4. Surface Maintenance Treatment (Seal Coat, Repairs and Crack Fill) (439,830 sf x .50/sf) (Paid Through Operating)	2026	as needed	\$	\$0	1	5
